EXPERT REPORT ON WHIRLPOOL FRONT-LOADING WASHER

DR. R. GARY WILSON, PH.D., P.E.

NOVEMBER 16, 2009

WHIRLPOOL FRONT-LOADING WASHER PRODUCTS LIABILITY LITIGATION

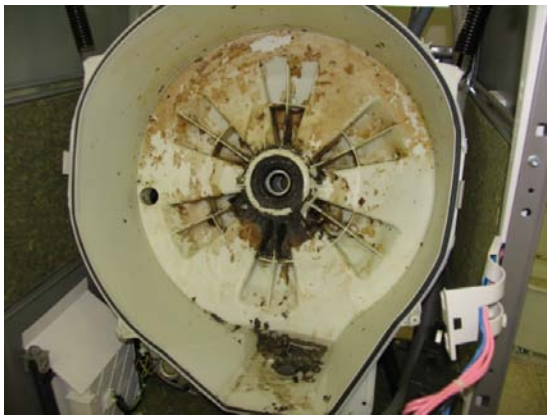
Figure 1: Tub Back Wall and Sump Area

The plastic tub is a major structural component that supports the basket by a shaft that runs through the back of the tub. This shaft with a heavy basket and bracket on one end is supported or cantilevered by the back of the tub (see Figure 5). The weight of the basket when it is full of wet clothes, the dynamic forces that are present when the basket is spinning and the off-balance forces that can occur requires a well designed wall in the back of the tub. As can be seen in the photographs in [Appendix D](#), the inside back wall of the tub is clearly engineered for strength and minimum material usage. The deep cavities and ribs all help to strengthen the tub so that it can support the basket. However, the cavities and structure are on the water side and in locations where rinse water cannot adequately reach the cavities to flush them out. As can be seen in the photographs in [Appendix C](#) the newer ACCESS has what appears to be a different plastic and the ribbing and cavities are placed on the back side of the tub out of contact with the wash water. The new HORIZON still has cavities on the water side.

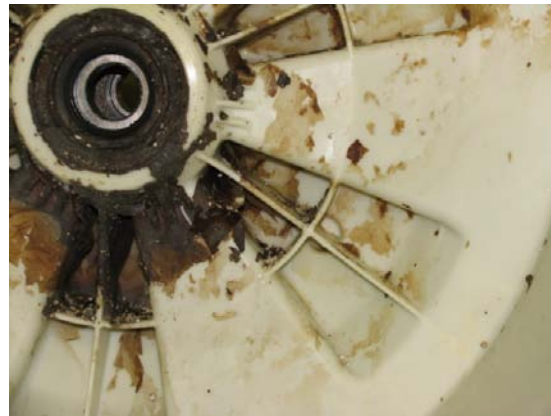
Figure 2: Tub Back Wall Close-up

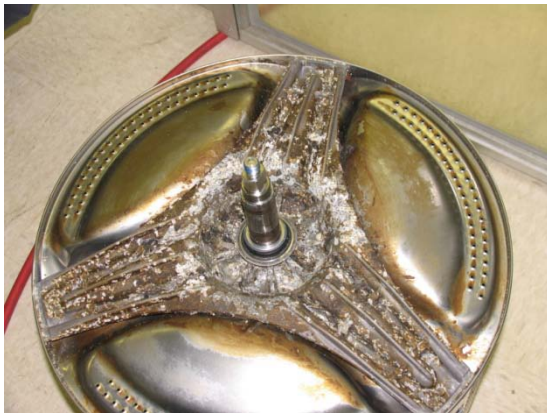
Figure 3: Basket Bracket

The heavy cast Aluminum bracket that is attached to the back of the basket has cavities which cannot be rinsed out to prevent the collection of material similar to that of the back wall of the tub (See [Appendix D](#)). Even with the spinning motion of the bracket severe amounts of debris still collect on the bracket. The photographs in [Appendix C](#) show that the newer ACCESS has basket brackets that have been redesigned to remove the cavities.

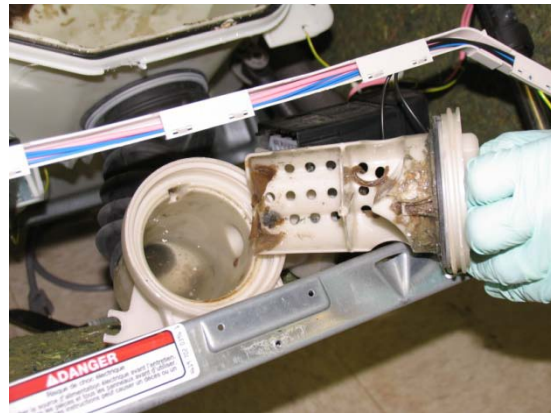
Figure 4: Pump Strainer

As the photographs in [Appendix D](#) and [F](#) show, the strainer can be a severe collection point and the drain hose with the corrugations also traps debris. This is probably one source of the odors that occur when the washer drains.

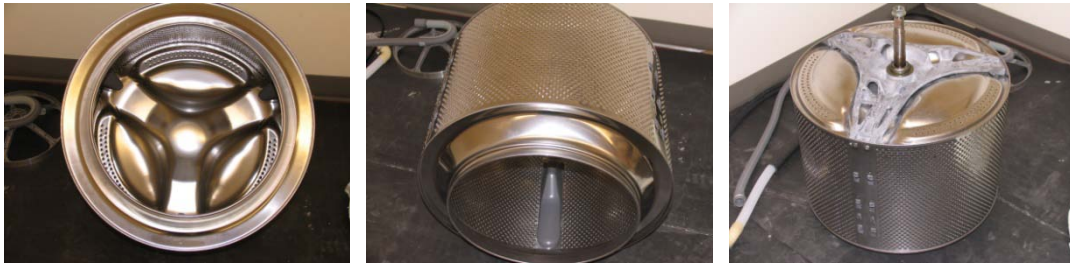
- The “Clothes Basket” or just “Basket” in which the clothes are held during the wash process. It is the orientation of the spin axis of the basket that determines the type of washer (horizontal or vertical axis).

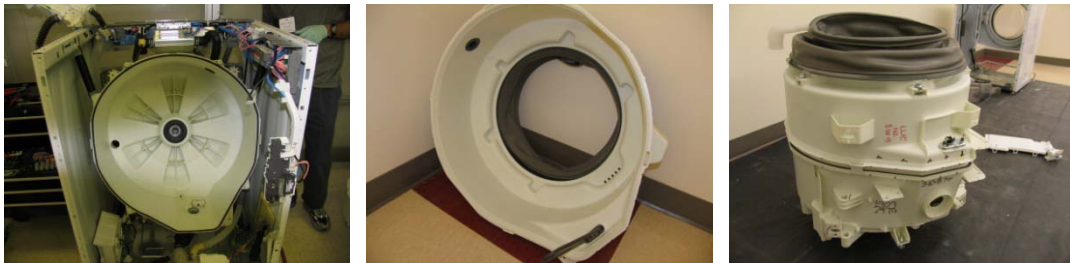
- The “Tub” surrounds the basket and contains the water/detergent mixture. During extraction of the wash water the basket spins within the tub and the water that is extracted from the clothes exits the basket through holes in the basket wall and is collected in the tub sump area and pumped to drain.
- The “Spin Motor” (right) which is either directly or indirectly attached to the basket and an electronic controller which can drive the motor at various speeds and in some cases in both a counter clockwise and clockwise direction.

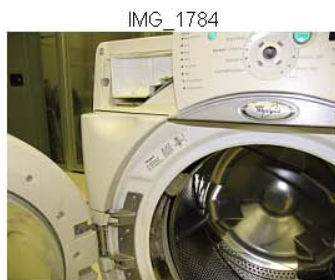
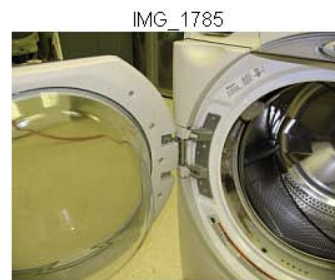
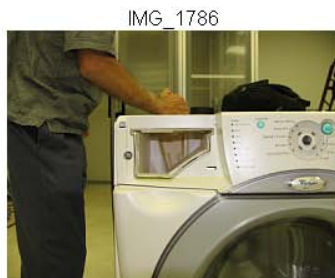
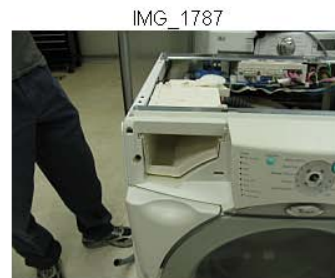
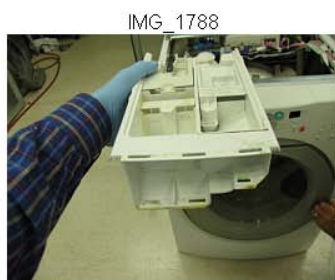
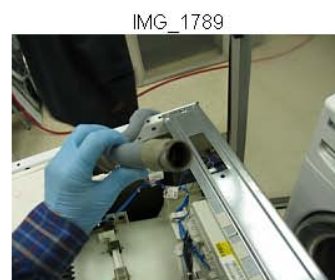
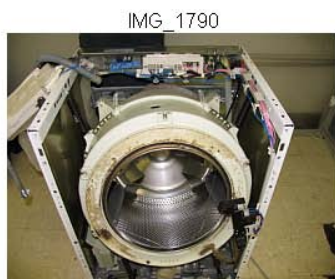
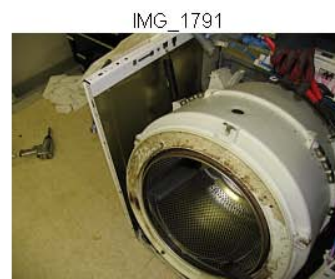
Serial No. CSM4712021 Build Date: week 47 of 2002
1 of 5

Serial No. CSM4712021 Model No. GHW9100LW1 Whirlpool Build Date: Week 47 of 2002
